Parker Street Waste Site

Public Information Plan (PIP) Meeting

Thursday - January 29, 2009

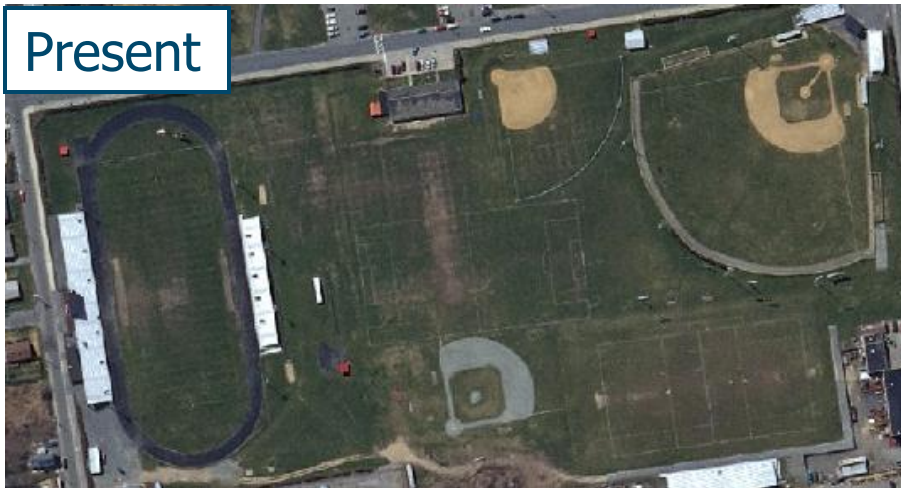
Present

- Primarily PAH and metals
- Non-detect (ND)/low-concentration PCBs
- Localized elevated arsenic in shallow soil on baseball diamonds

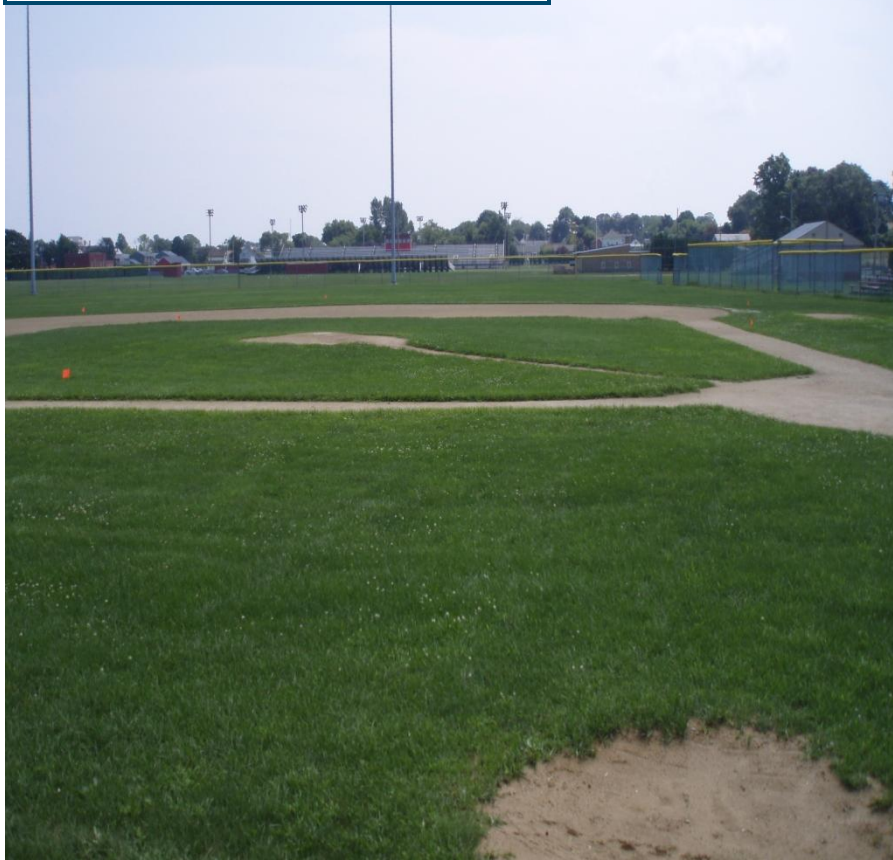
Varsity Summer 2008

- ❑ Varsity and Jr. Varsity Fields
 - Elevated arsenic soil concentrations
 - Triggered potential Imminent Hazard (IH) reporting and evaluation.
 - Other areas O.K.
- ❑ Findings
 - IH condition at Varsity Field
 - No IH at JV Field
- ❑ Immediate Response Action (IRA)
 - RTN 4-21407

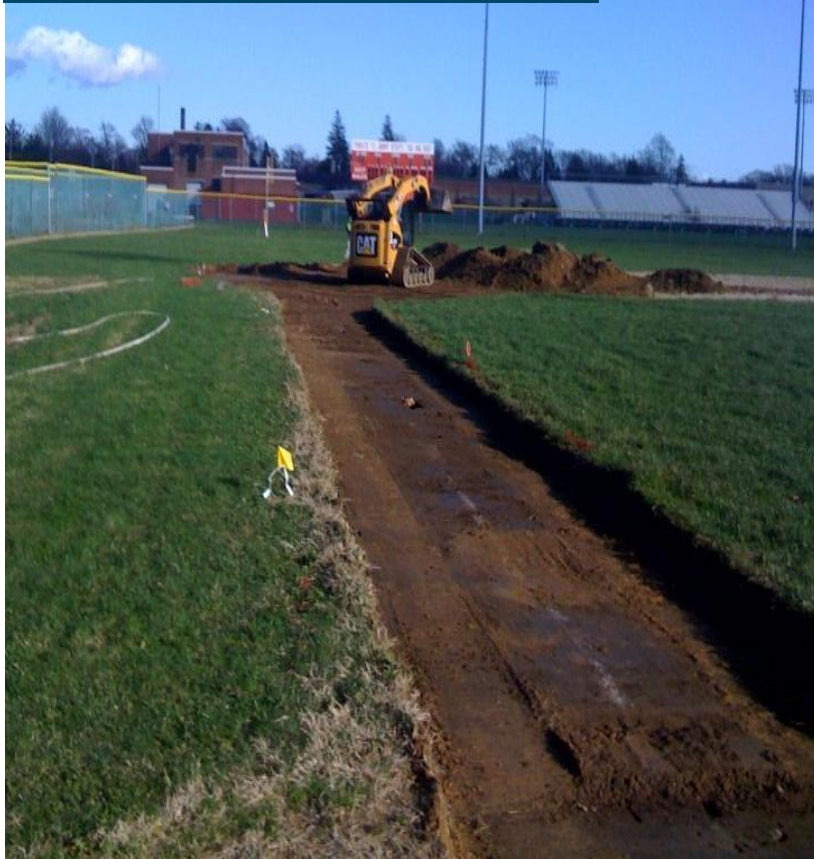
Varsity November 2008

- ☐ Reported to MassDEP (2-hour)
 - July 30th
- ☐ Supplemental soil sampling/risk analysis
 - August 2008
- ☐ Filed IRA* plan & Spec. Waste Determ.
 - November 2008
- ☐ Regulatory approval of IRA
 - November 2008
- ☐ Mayor directed additional removal
 - November 2008
- ☐ MassDEP approved Mayor's request
 - November 2008
- ☐ Soil removal and additional sampling
 - November 2008

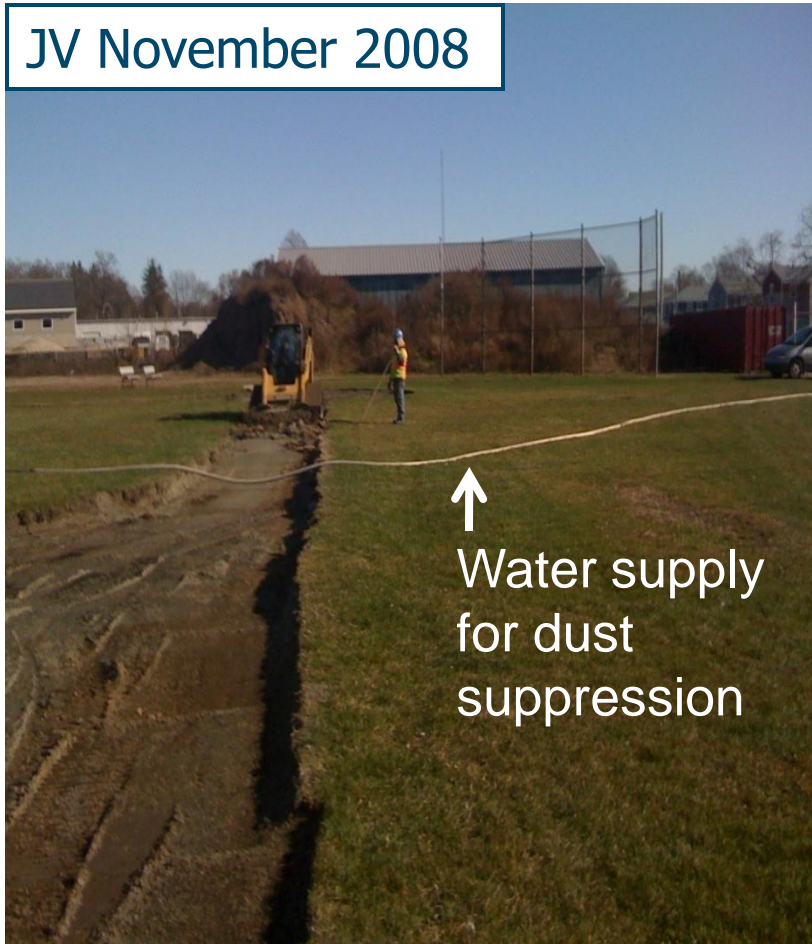
JV November 2008

Water supply
for dust
suppression

- ☐ Access restricted
- ☐ Arsenic surface soil removed
- ☐ Dust suppression/monitoring
- ☐ On-going risk evaluation
- ☐ Achieved significant risk reduction
 - Mitigated IH at Varsity
 - Further reduced risk at JV

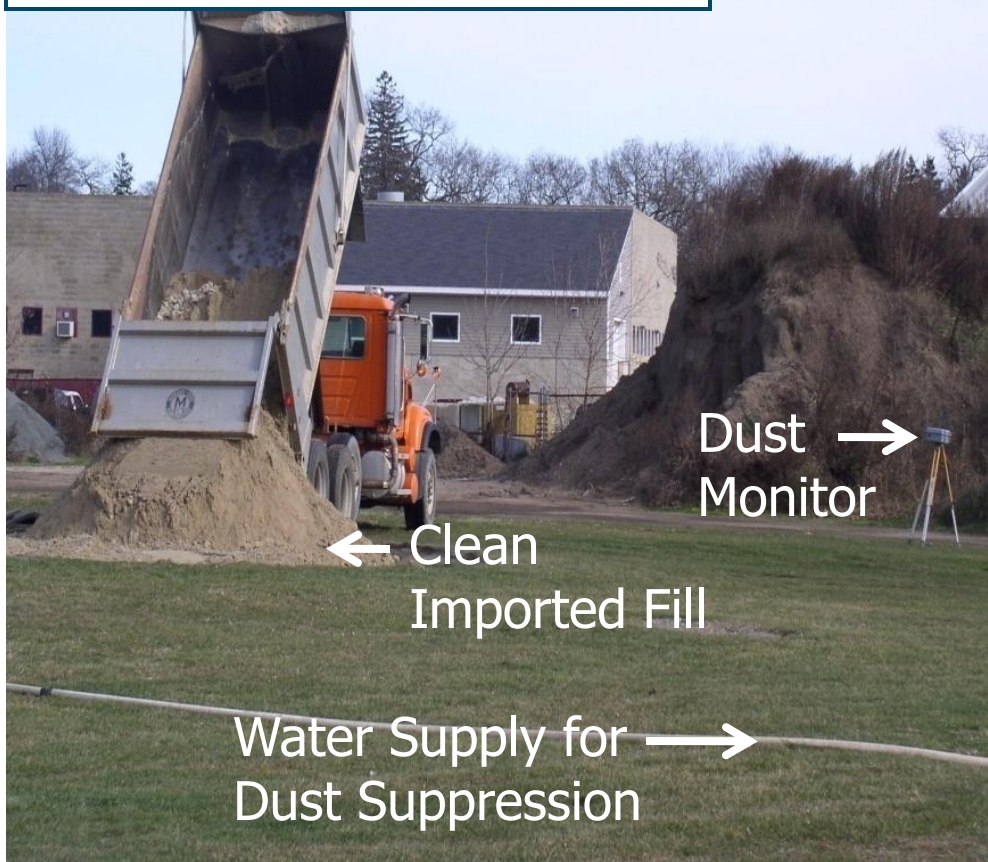
JV November 2008 Example

- ☐ Real-time field instrumentation and back-up laboratory analysis
- ☐ No dust levels in excess of action levels.
- ☐ All arsenic air results non-detect *

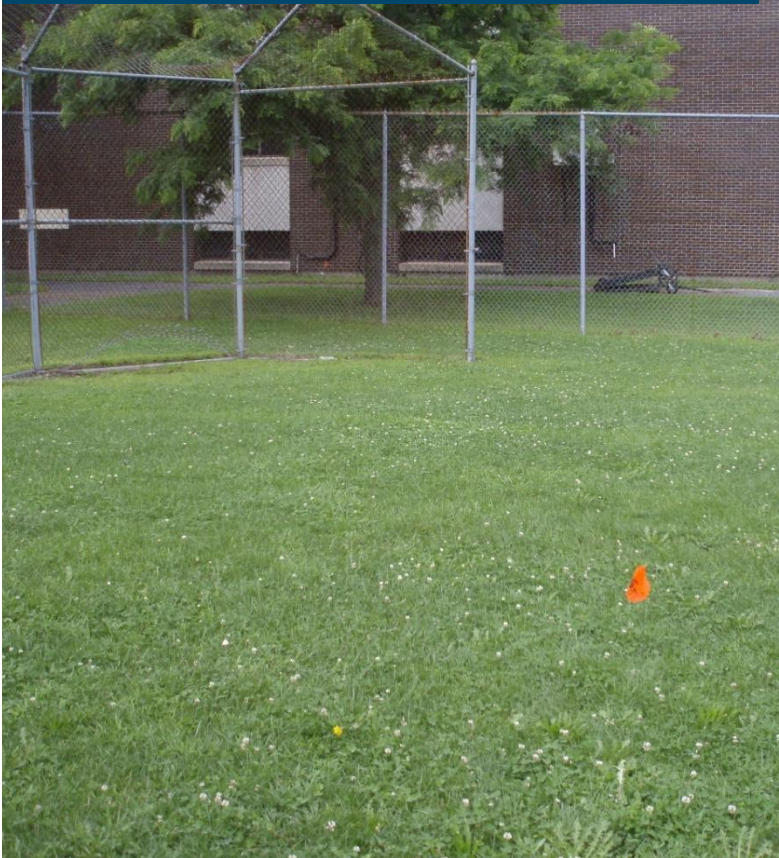
NBHS Ball Field Summer 2008

- Generally consistent with past work by BETA
- Groundwater data also collected

- Precautionary surface soil data collection following Walsh Arsenic discovery
- No exposures of concern detected in shallow soil (0 -1 foot below grade).

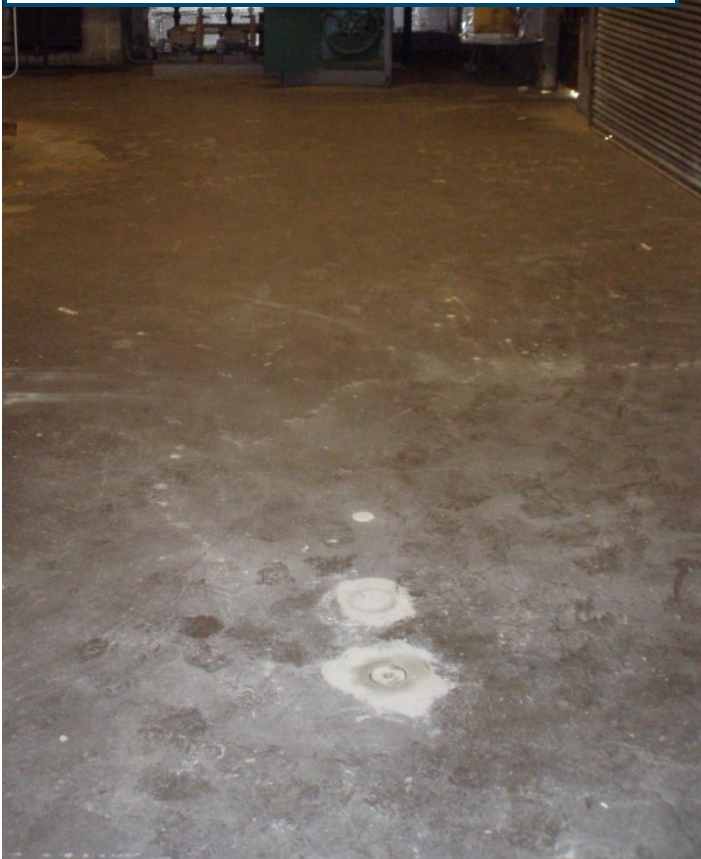
Boiler Room Summer 2008

- 8 sub-slab soil borings
- Low concentration PCBs
- Sporadic metals above standards
- One PAH detect above standard [benzo(a)pyrene].

- 3 sub-slab wells/2 exterior wells
- Exceedance in one well due to turbidity (boiler room)
- Filtered result OK

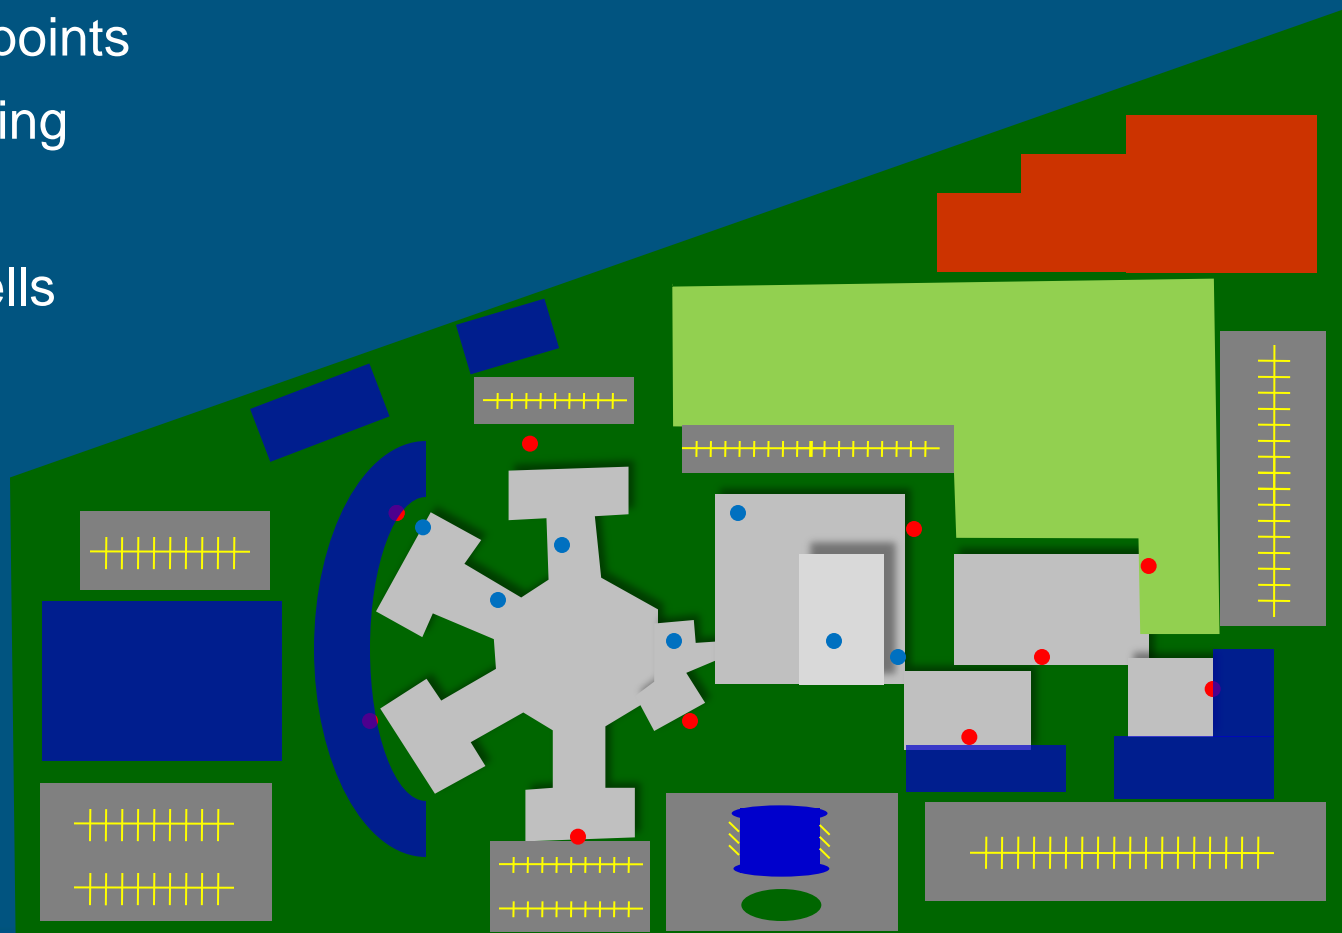
Investigation Locations

- ❑ 63 hand auger points
- ❑ 47 machine boring
- ❑ 264 Samples
- ❑ 5 Monitoring wells

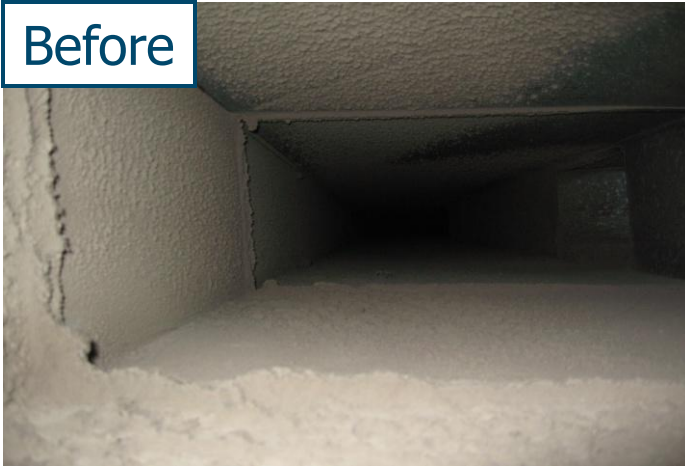
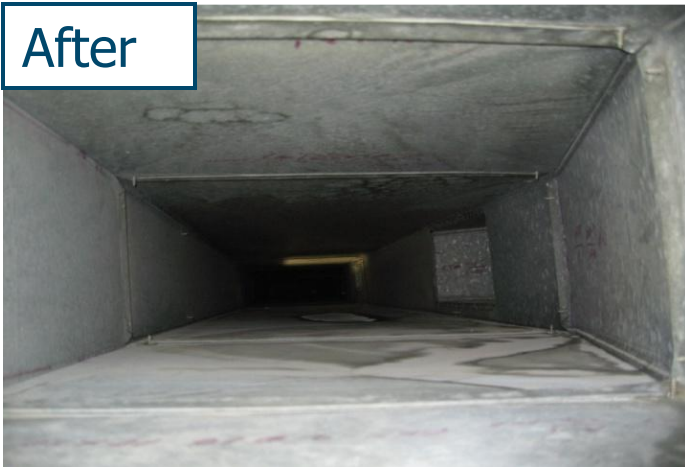
- ☐ Remediation Initiated

- ☐ Remediation Completed

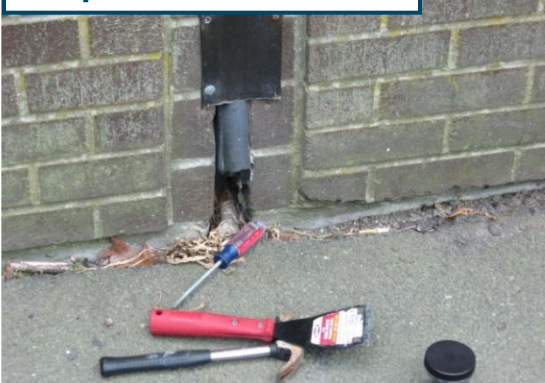
Expansion Joint

- ❑ Additional PCB-containing building materials (e.g., adhesives, gaskets)
- ❑ Numerous low-concentration building materials serve as sources of indoor air PCBs
- ❑ Higher PCB air concentrations trend with higher aggregate PCB building material concentrations

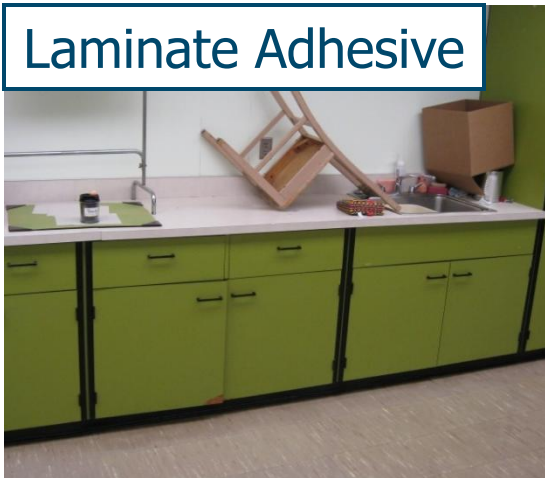
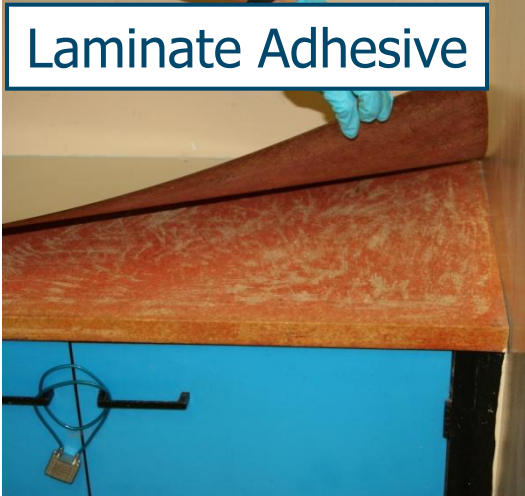
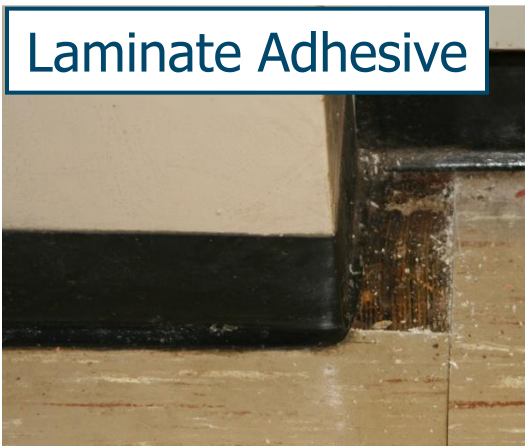
Laminate Adhesive

- PCBs detected in 57 out of 63 building material samples
- Concentration range: 0.16 ppm to 230 ppm (Total PCBs)

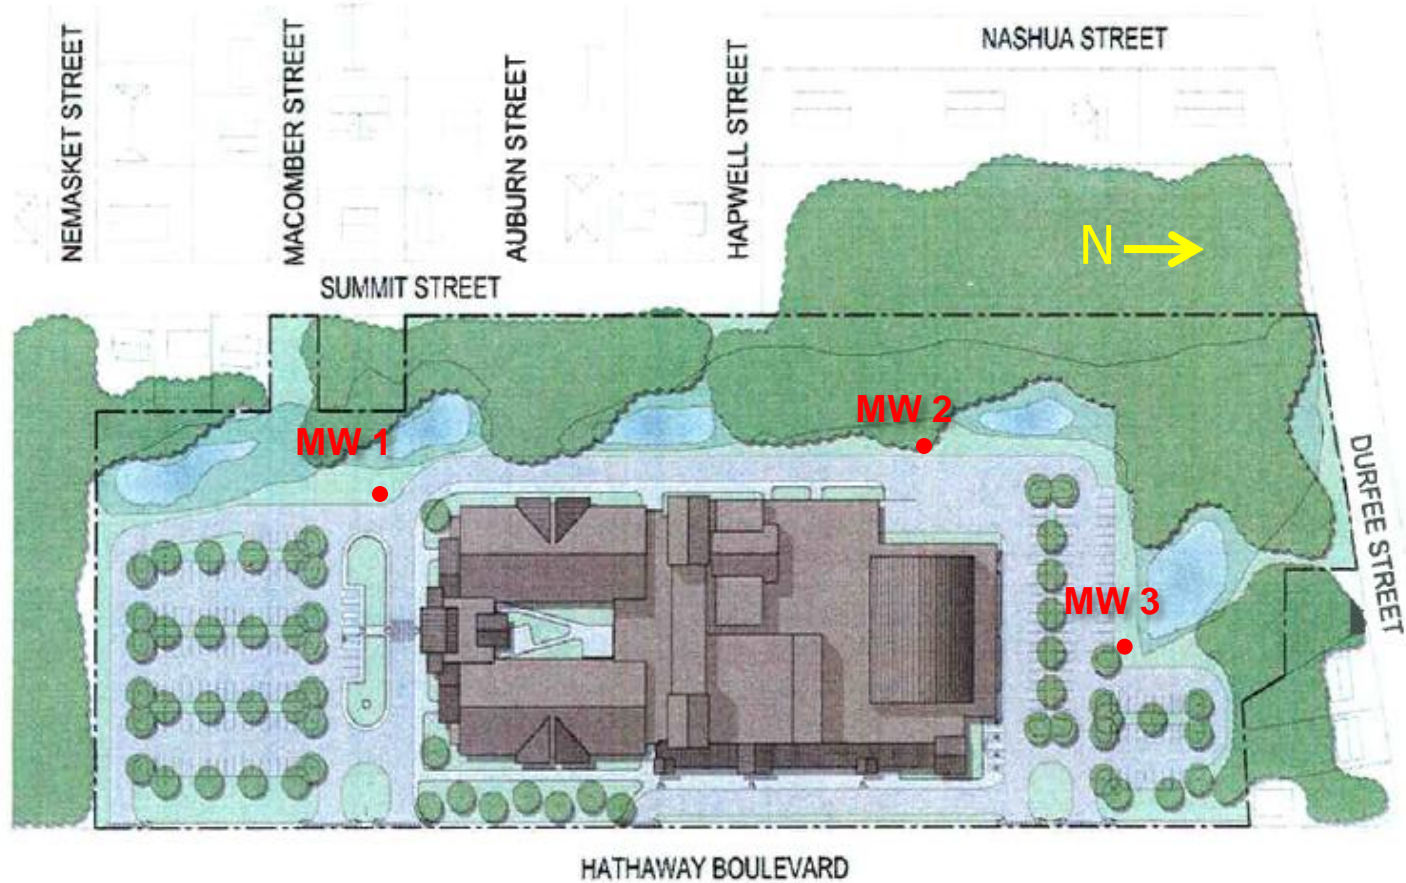
Groundwater Monitoring Well Locations

- VOCs: All non-detect (except MTBE, below standards)
- PCBs: All non-detect
- Metals: No detections above standards

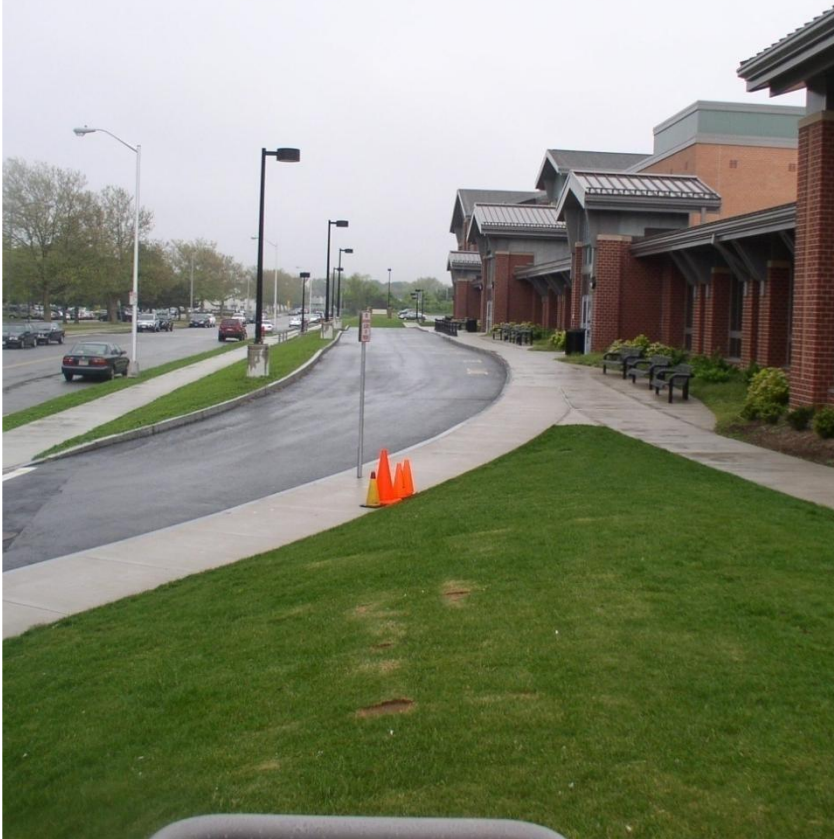
KMS Front Entrance (View South)

- Walking traverse of entire site
- Visual observations of entire cap
 - First floor concrete slab
 - Interior courtyard
 - All asphalt and landscaped surfaces

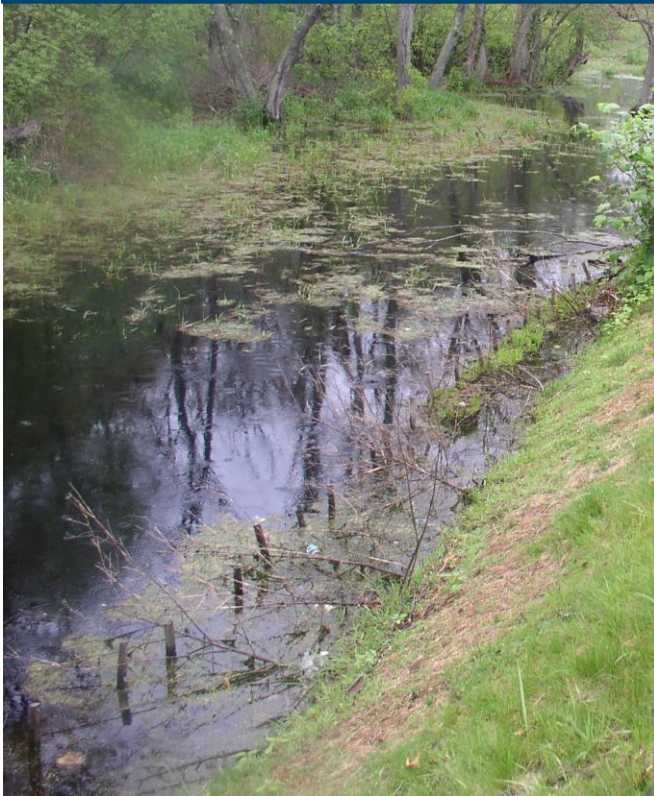
KMS North Wetland (View North)

- Concrete slab in acceptable condition
- Exterior pavement and concrete surfaces in acceptable condition
- Courtyard surfaces in acceptable condition
- Exterior landscaped areas are acceptable except as follows:
 - Sparse vegetation - southern slope
 - Area of slope failure (**recently repaired**).
 - Sloughing rip-rap - west side/storm drain
 - Minor erosion - northwest corner

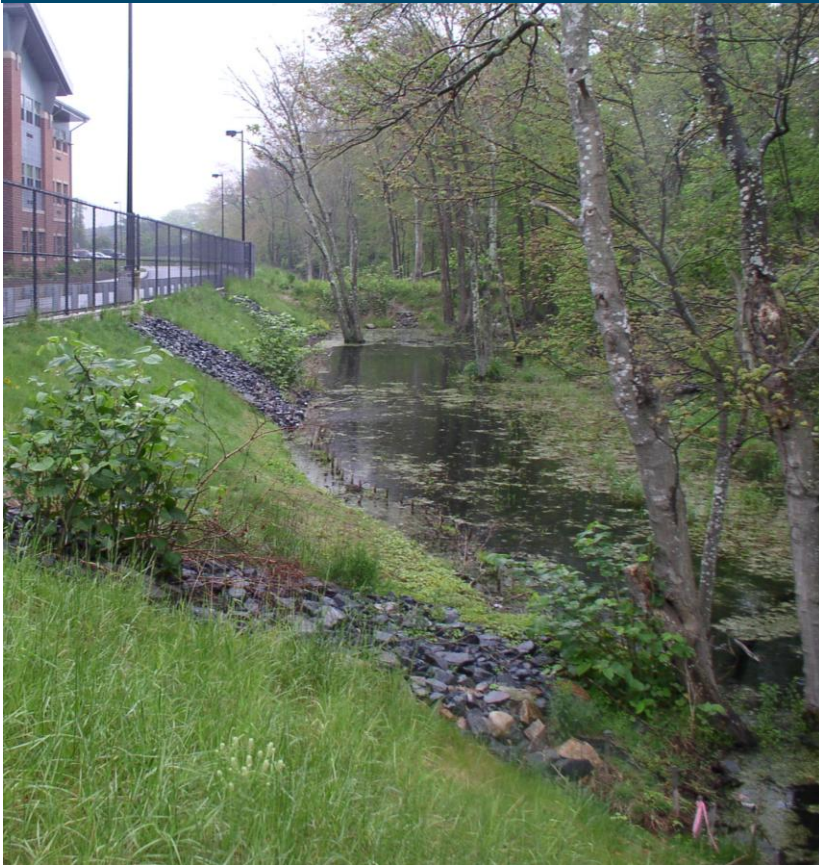
KMS North Wetland (View South)

- Walking traverse of top & toe of slope
- Look for unacceptable conditions:
 - Excessive sedimentation
 - Conditions that could cause excessive sedimentation
 - Vegetation conditions

- Generally well vegetated slope
 - Exploring vegetation/animal control options
- Similar erosion issues as noted in cap inspection
- Temporary repair still viable with some localized soil migration around the lower hay bales (permanent repair implemented since time of inspection).

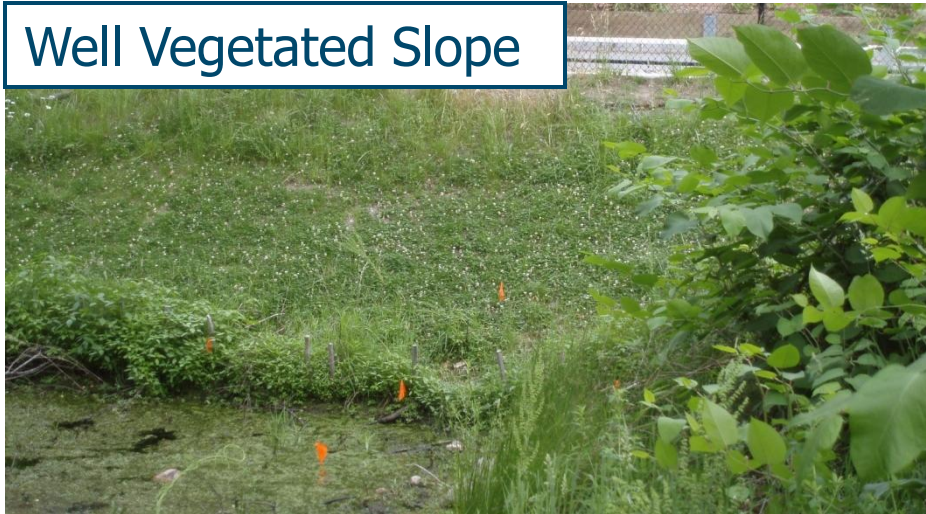
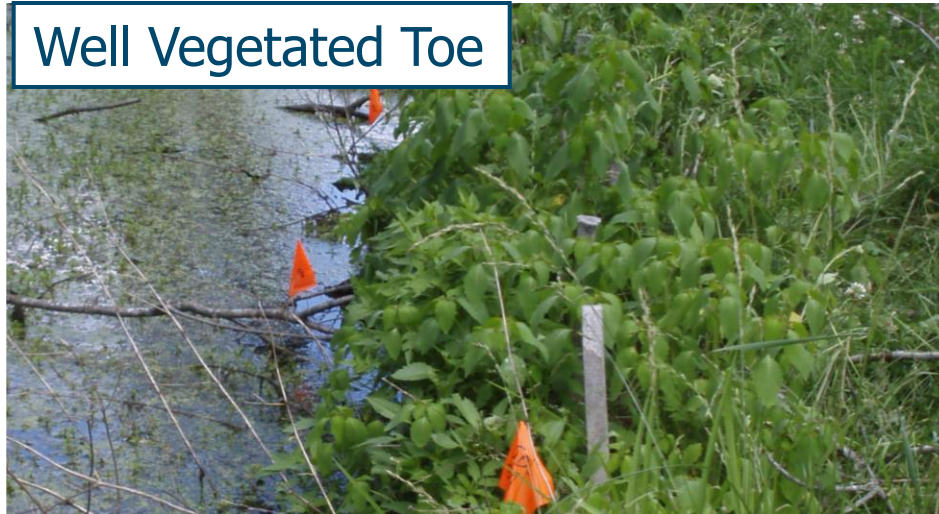
Well Vegetated Slope

Well Vegetated Toe

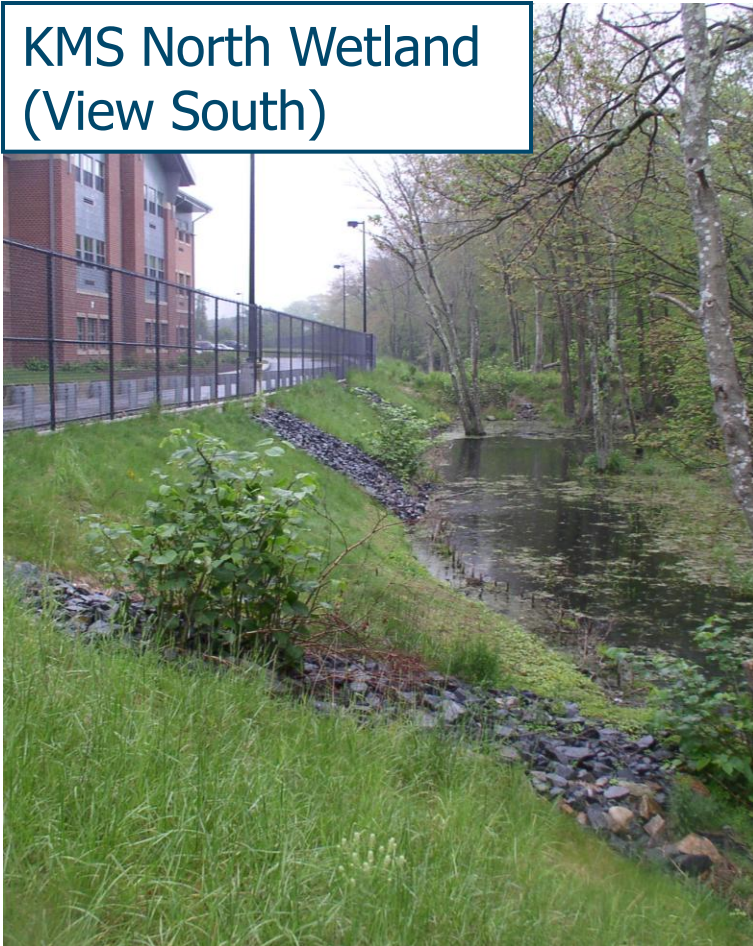
KMS North Wetland
(View South)

- ❑ Long-Term Monitoring and Maintenance Implementation Plan (LTMMIP)
- ❑ Sampled Spring 2008
- ❑ Monitoring scope
 - Four randomly collected sediment samples (base of slope)
 - Analyze samples for PCB Aroclors (Method 8082)

- Three out of four samples non-detect
- One sample detected PCBs (16.6 mg/kg)
- Triggered potential Imminent Hazard reporting and evaluation under the MCP (reported to MassDEP)
- Preliminary calculations indicate an Imminent Hazard exists (TRC's calculations slightly exceed the Imminent Hazard criteria set forth in the MCP under 310 CMR 40.0955)
- *Delineation and evaluation ongoing*
